# The Uniform Building Inspection Report™

**Single Family Residence:**  
1234 N. Mystreet, Phoenix, AZ

**Inspection Date:**  
1/1/2010, 9:00:00 AM

**Report Number:**  
1810012210

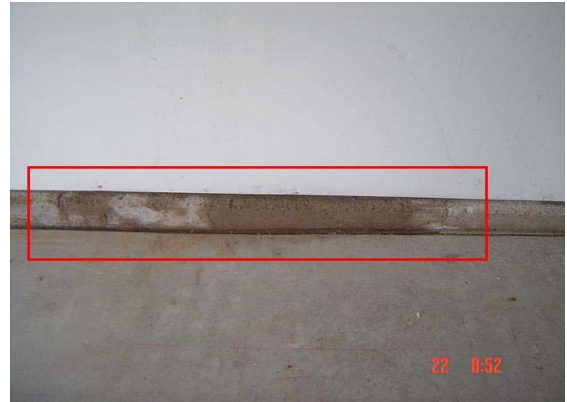
Photo: 0080.02 (1)

[D] 0080.02: Hardscape not sloped away from building.  
Noted that the front walkway next to the garage is not sloped away. Water is soaking through the wall into the garage at this time.  
See Photo(s) 0080.02.

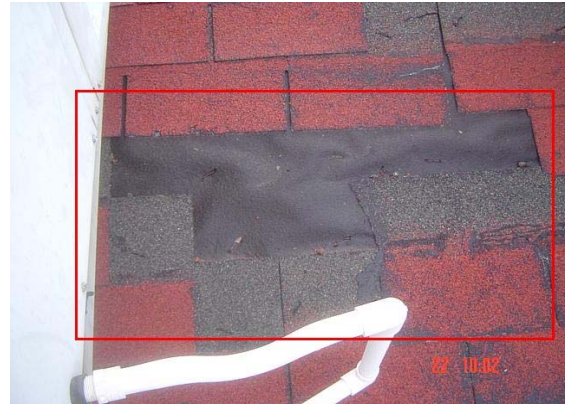
Photo: 1020.02 (1)

[R] 1020.02: Part of the roof appears to be at the end of its useful life. Prepare to replace some areas at this time. A second opinion is recommended.

Noted missing shingles and damage to the roof around the roof top HVAC unit. The roof needs to be replaced. It is actively leaking into a second floor bedroom. It is recommended that the finding, and all associated components, be reviewed, and corrected as needed, by a qualified licensed contractor before purchasing the property. See Photo(s) 1020.02.

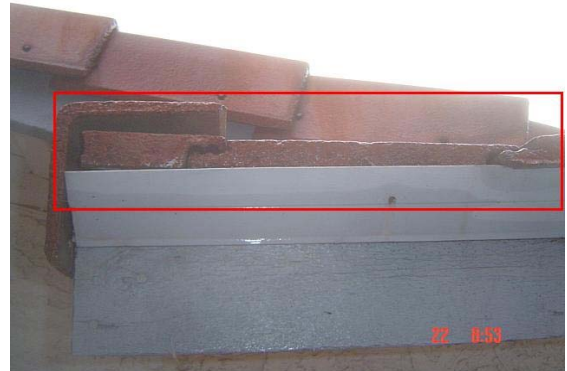
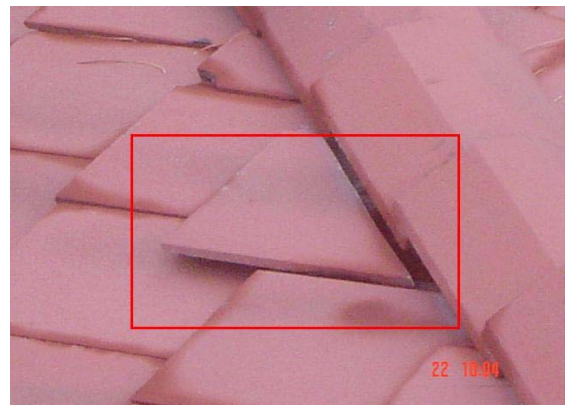
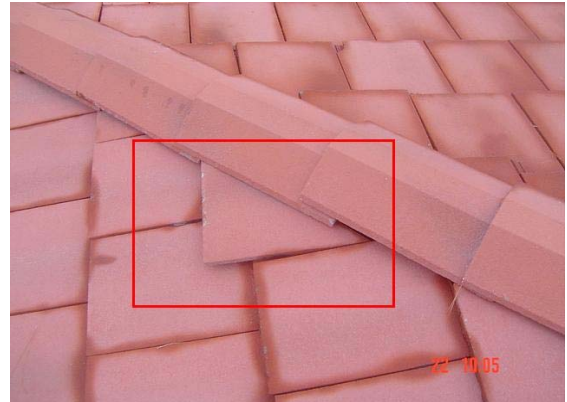
[D] 1080.03: Roof tiles out of position.

Noted that one of the tiles on the west side of the garage, near the front entry is not extended far enough of the metal drip edge. Water is getting under the drip edge causing water stains to the plywood roof sheathing in this area.  
2. Noted that several of the cut hip tiles are not adhered down and have slid out of position. Wind driven rain will get under the tiles and in time cause damage to the interior or fly off the roof. Significant component damage and/or ongoing damage apparent. Before purchasing the property, needed corrections by a qualified licensed contractor are advised.  
See Photo(s) 1080.03.

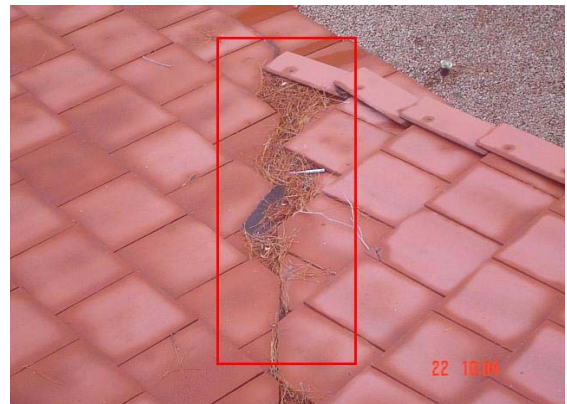
Photo: 1120.01 (1)

[P] 1120.01: Clean debris from roof.  
Noted debris blocking at the valley on the west side of the roof above the garage. With debris in the valleys, the water will be diverted to areas not designed to handle the added flow of water. Correction or modification decreases the probability of continued and excessive deterioration.  
See Photo(s) 1120.01.

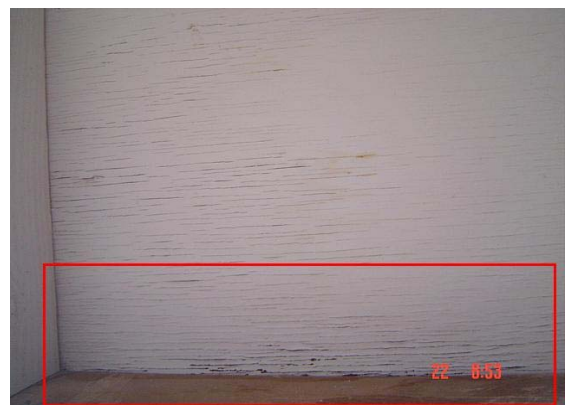
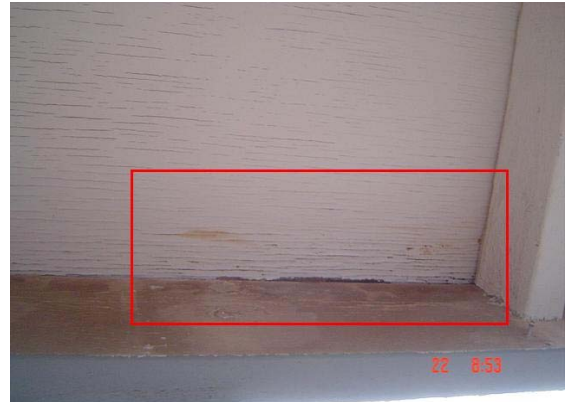
[D] 1170.01: Roof leak evidence noted. (stained wood, etc.)  
Noted water stains to the under side of the roof sheathing on the west side of the garage, at the SE corner of the garage and at the SW corner of the roof above the front entry. Significant component damage and/or ongoing damage apparent. Before purchasing the property, needed corrections by a qualified licensed contractor are advised.  
See Photo(s) 1170.01.

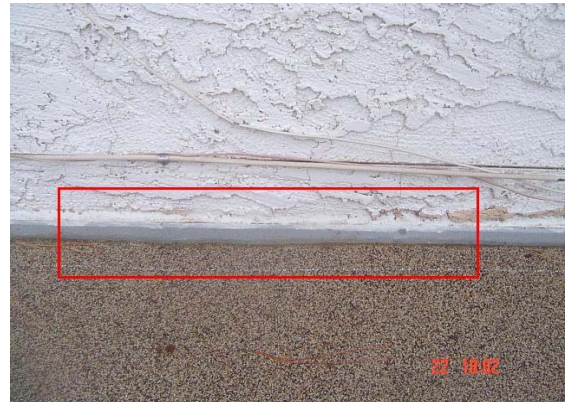
Photo: 1230.04 (1)

[M] 1230.04: Metal flashing faulty or otherwise amiss.  
Noted that the roofing on the rear patio roof is sitting on top of the metal flashing next to the wall and not under it. Monitor the situation on a regular basis. Corrections by a qualified licensed contractor, if and when necessary, are recommended.  
See Photo(s) 1230.04.

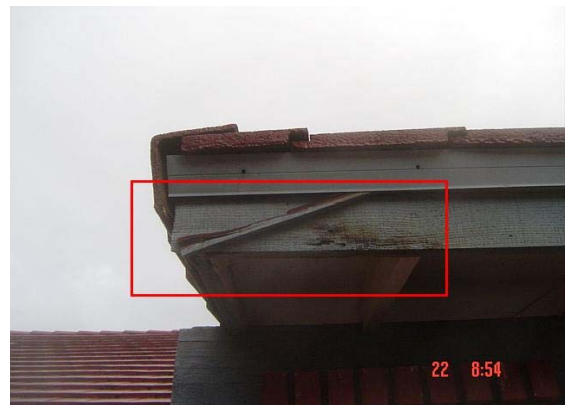
Photo: 1450.01 (1)

[D] 1450.01: Fascia damaged.  
Noted dryrot damage to the fascia at the SW corner of the roof above the front entry. Significant component damage and/or ongoing damage apparent. Before purchasing the property, needed corrections by a qualified licensed contractor are advised.  
See Photo(s) 1450.01.

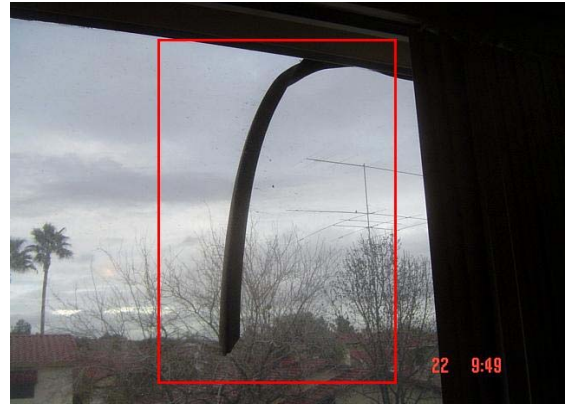
Photo: 1500.05 (1)

[P] 1500.05: Glazing faulty or otherwise amiss.  
Noted that one of the outside trim strips has come loose on the north face master bedroom window. Correction or modification decreases the probability of continued and excessive deterioration.  
See Photo(s) 1500.05.

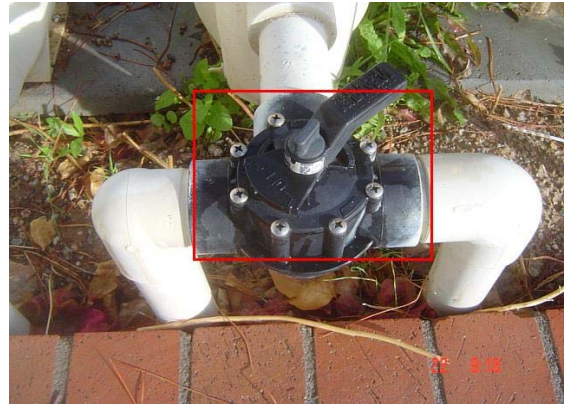
Photo: 3570.10 (1)

[F] 3570.10: Valve leak(s).  
Noted leaking from the diverter valve in front of the pump. This may be the cause of air in the lines. A system or component fails to function, or to function properly. Before purchasing the property a total review of all affected systems by a qualified licensed contractor is advised.  
See Photo(s) 3570.10.

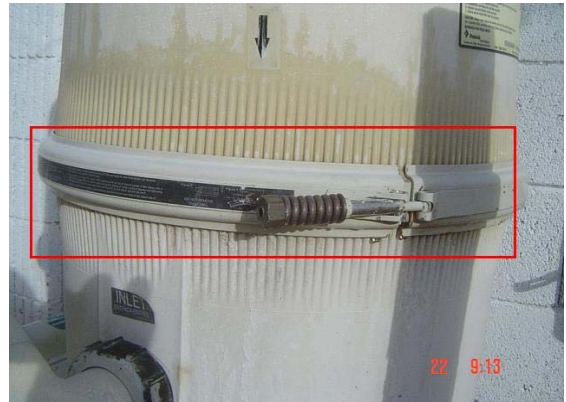
Photo: 3770.02 (1)

[F] 3770.02: Filter case leaks.  
Noted leaking from the center connection band on the filter. It may be in need of a new "O" ring.  
See Photo(s) 3770.02.

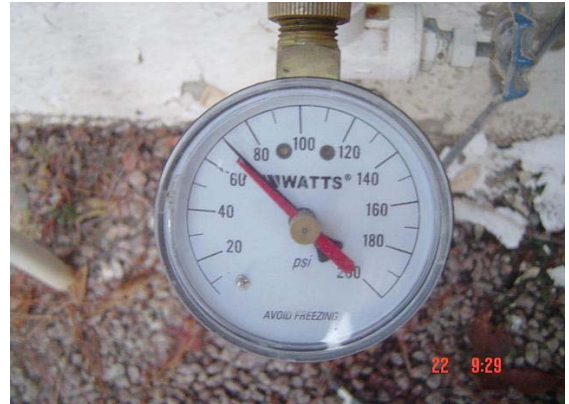
Photo: 4000 (1)

[Note] 4000 The water pressure at the time of the inspection was 70 PSI ( over 80 PSI is too much, 40 PSI is too little).See Photo(s) 4000.

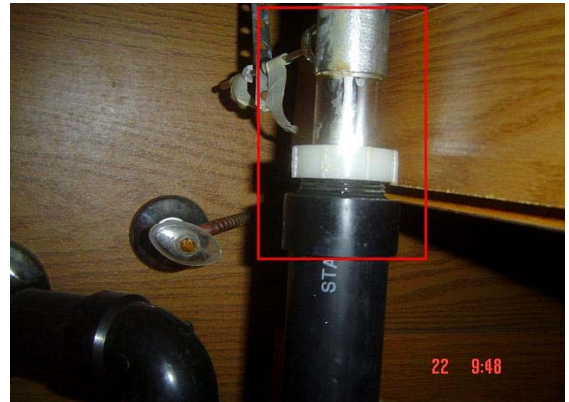
Photo: 4600.11 (1)

[F] 4600.11: Fixture drain line leaks.  
Noted leaking from the top coupling under the left side master bath sink. A system or component fails to function, or to function properly. Before purchasing the property a total review of all affected systems by a qualified licensed contractor is advised.  
See Photo(s) 4600.11.

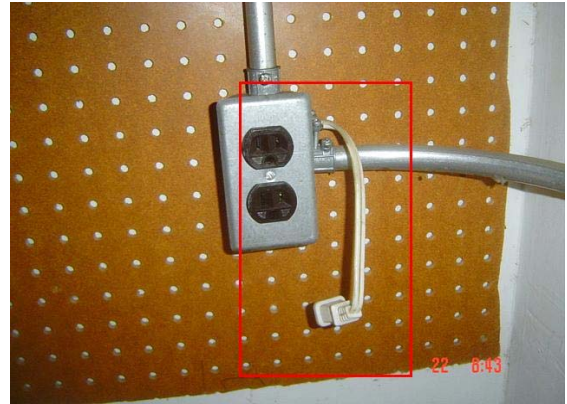
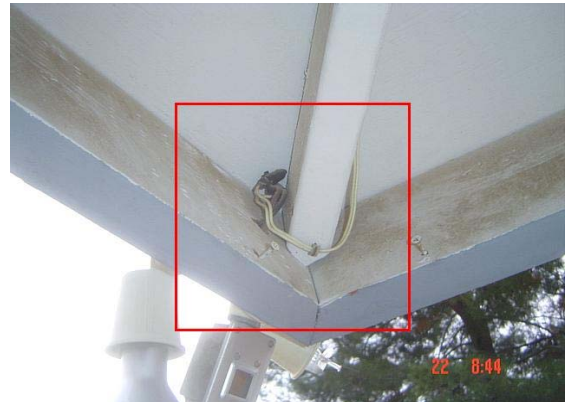
Noted that when plugging in the cord into the outlet on the SW corner in the garage, sparks came flying out of the outlet and tripped the breaker. The cord runs to a motion light on the exterior corner of the garage. This type of cord is not designed for this purpose and needs to be completely removed. Secondly, the connects to the outside light are not in a J-box. The finding should be considered hazardous. Corrections by a qualified licensed contractor, before purchasing the property, are advised. See Photo(s) 5370.06.

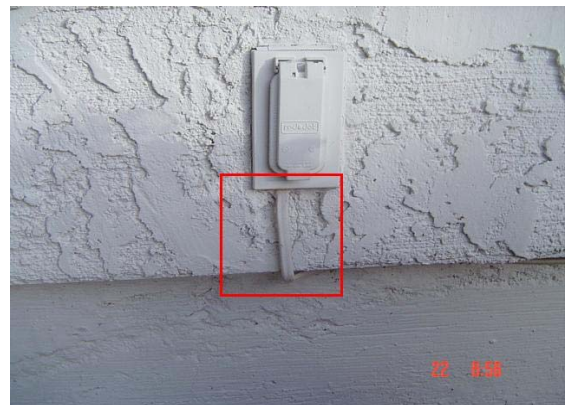
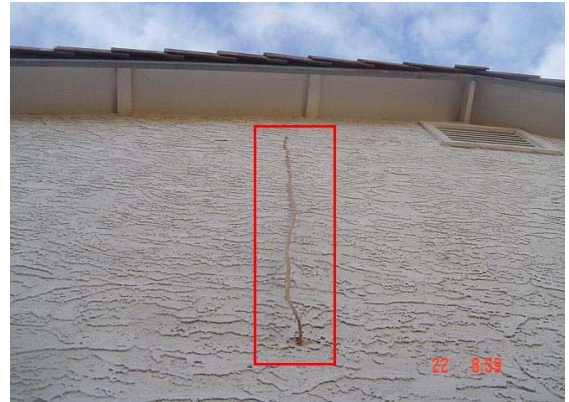
[R] 5440: Nonmetallic sheathed cable exposed where could be damaged.

Noted a wire coming out of the exterior outlet on the front of the house and going over to the sprinkler timer box next to the main water shut off. Noted two wires coming out of the stucco wall on the west side of the house. None of these wires are in a protective conduit. It is unknown what purpose the wires on the west wall serve. It is recommended that the finding, and all associated components, be reviewed, and corrected as needed, by a qualified licensed contractor before purchasing the property. See Photo(s) 5440.

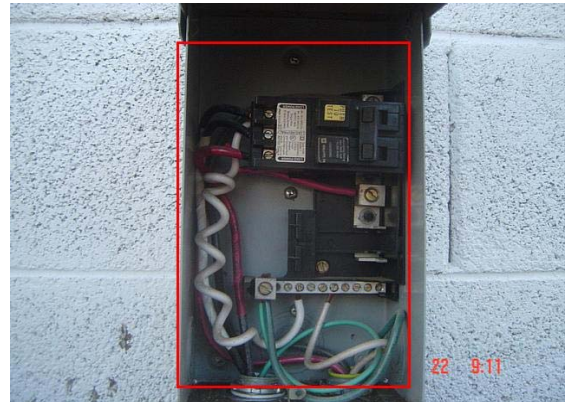
Photo: 5820 (1)

[H] 5820: Exterior / interior contact hazard.

Noted that the sub panel on the wall next to the pit in the rear corner of the lot is missing a dead front cover. The electrical connections are exposed to contact. A cover need to be installed. The finding should be considered hazardous. Corrections by a qualified licensed contractor, before purchasing the property, are advised.  
See Photo(s) 5820.

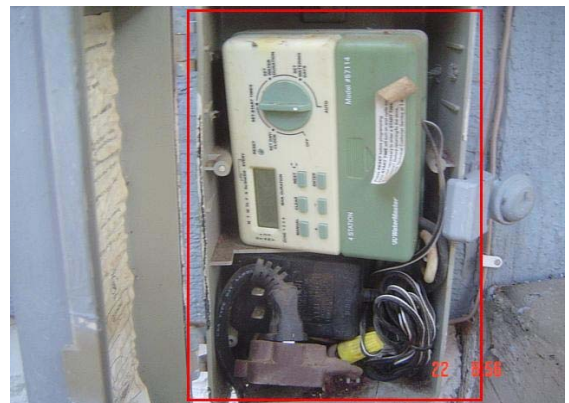
Photo: 5910 (1)

[C] 5910: Finding not covered in narratives.  
Noted that the box used to house the sprinkler timer at the front of the house is overloaded. It looks like a fire waiting to happen. Caution is advised. The finding could be, or could become, hazardous under certain circumstances. The opinion of a qualified licensed contractor is recommended. See Photo(s) 5910.

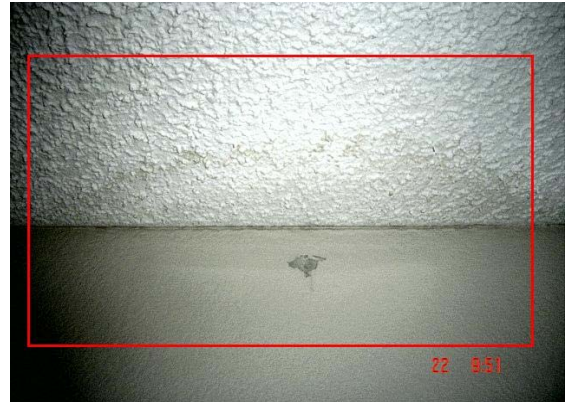
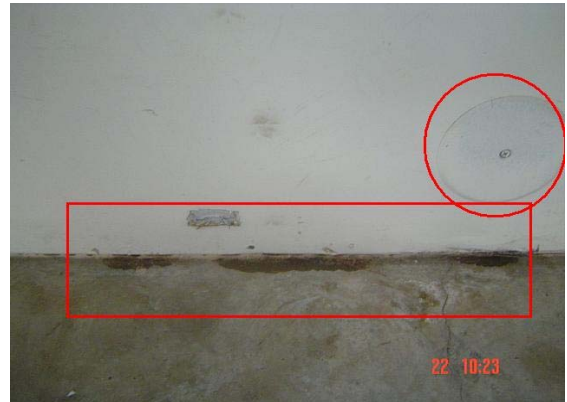
[R] 7010: Water intrusion evidence or water damage noted. Noted an active leak in the ceiling of the right side north face bedroom. The roofing above this area is heavily damaged. 2. Noted that the floor on the north wall of the garage is wet. The area is next to the plumbing cleanout, which could be the cause of the moisture.

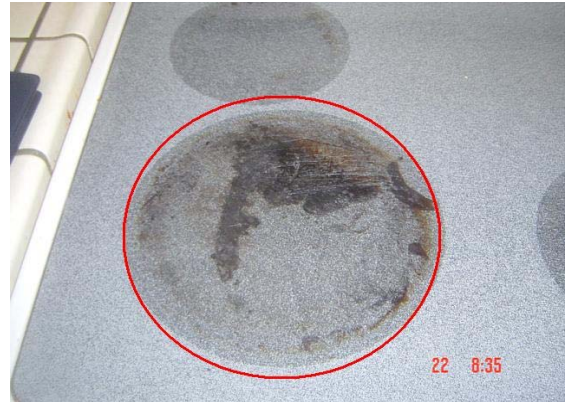
Photo: 8020.11 (1)

#### [A] 8020.11: Range damaged.

Noted discoloration to the cooktop surface. Maintenance, alteration or repair could be expected to improve component appearance and may decrease deterioration. See Photo(s) 8020.11.
